Impact of River Bank Erosion on Human Life: A Study of Sub-Himalayan North Bengal Region in India From Geographical Perspective

Madhusudan Karmakar

Assistant Professor, Maynaguri College

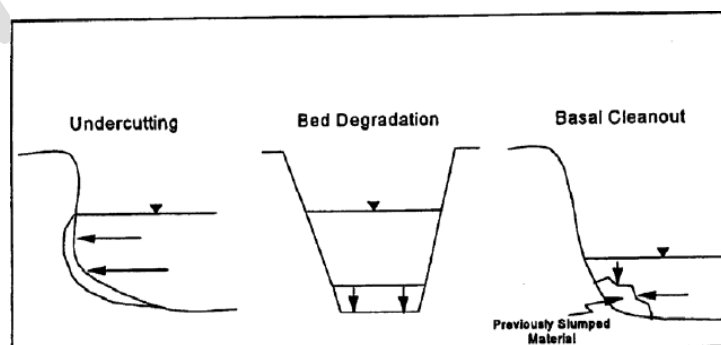
Hydraulic Processes

Processes	Characteristics
<i>Hydraulic processes</i>	Bank undercutting, bed degradation, and basal clean-out
<i>Gravitational failures</i>	
Rotational failures	It is a result of scour at the base of the bank and/or high pore water pressure within the bank material where the slopes less than 60°.
<i>Slab failure</i>	It results from the combination of scour at the bank toe, high pore water pressure in the bank material and the development of tension cracks at the top of the bank.
<i>Cantilever failures</i>	It is the collapse of an overhanging block into the channel, often occurring after the bank has been undercut.
<i>Pop out failure</i>	It is a term used to describe failures where small to medium sized blocks are forced out at or near the base of the river bank due to excessive pore water pressure and overburden.
<i>Piping failure</i>	This is the collapse of part of the bank due to high groundwater seepage pressures and rates of flow causing selective removal of sections of the bank

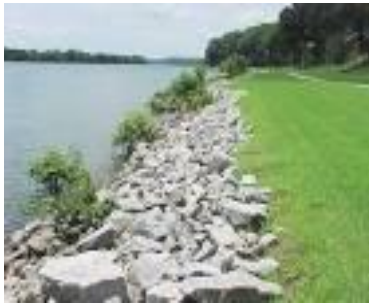
Riprap structures

1. Riprap made of rocks and other materials, arranged in a way as to inhibit erosional processes on a river bank. This method is expensive and can experience failure, but has the ability to be used for large areas.

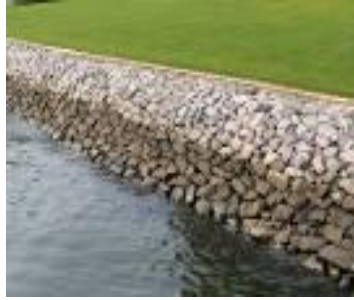
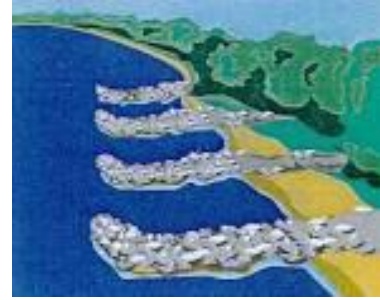
Spur dam structure

6. In the erosion prone areas spur dams are very effective where meandering bends cause bank erosion.

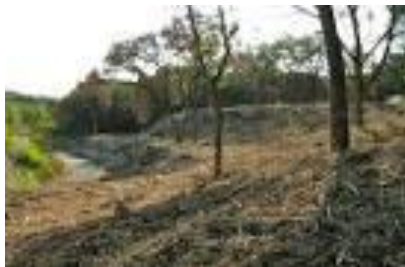
Windrows or Slash Terraces

2. Windrows are the piling of erosion-resistant material on a river's bank, where if buried, they become known as trenches. When erosion persists an already determined location, these windrows and trenches are made to slide down with the bank in order to protect it from further occurrences of erosion.

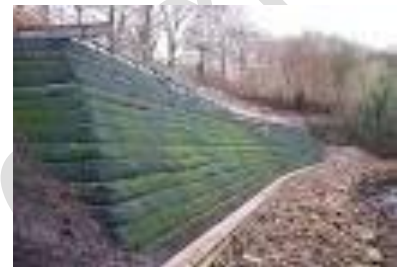
Soil cement Structure

4. The exact placement of soil cement may be different depending on the slope of the bank. In rivers with high wave action, a stair step pattern may be needed to dissipate the energy coming from the waves
